U. S. Bureau of Agricultural Engineering

Photo #3

April 30, 1940

Waterman, Illinois, DeKalb Co.

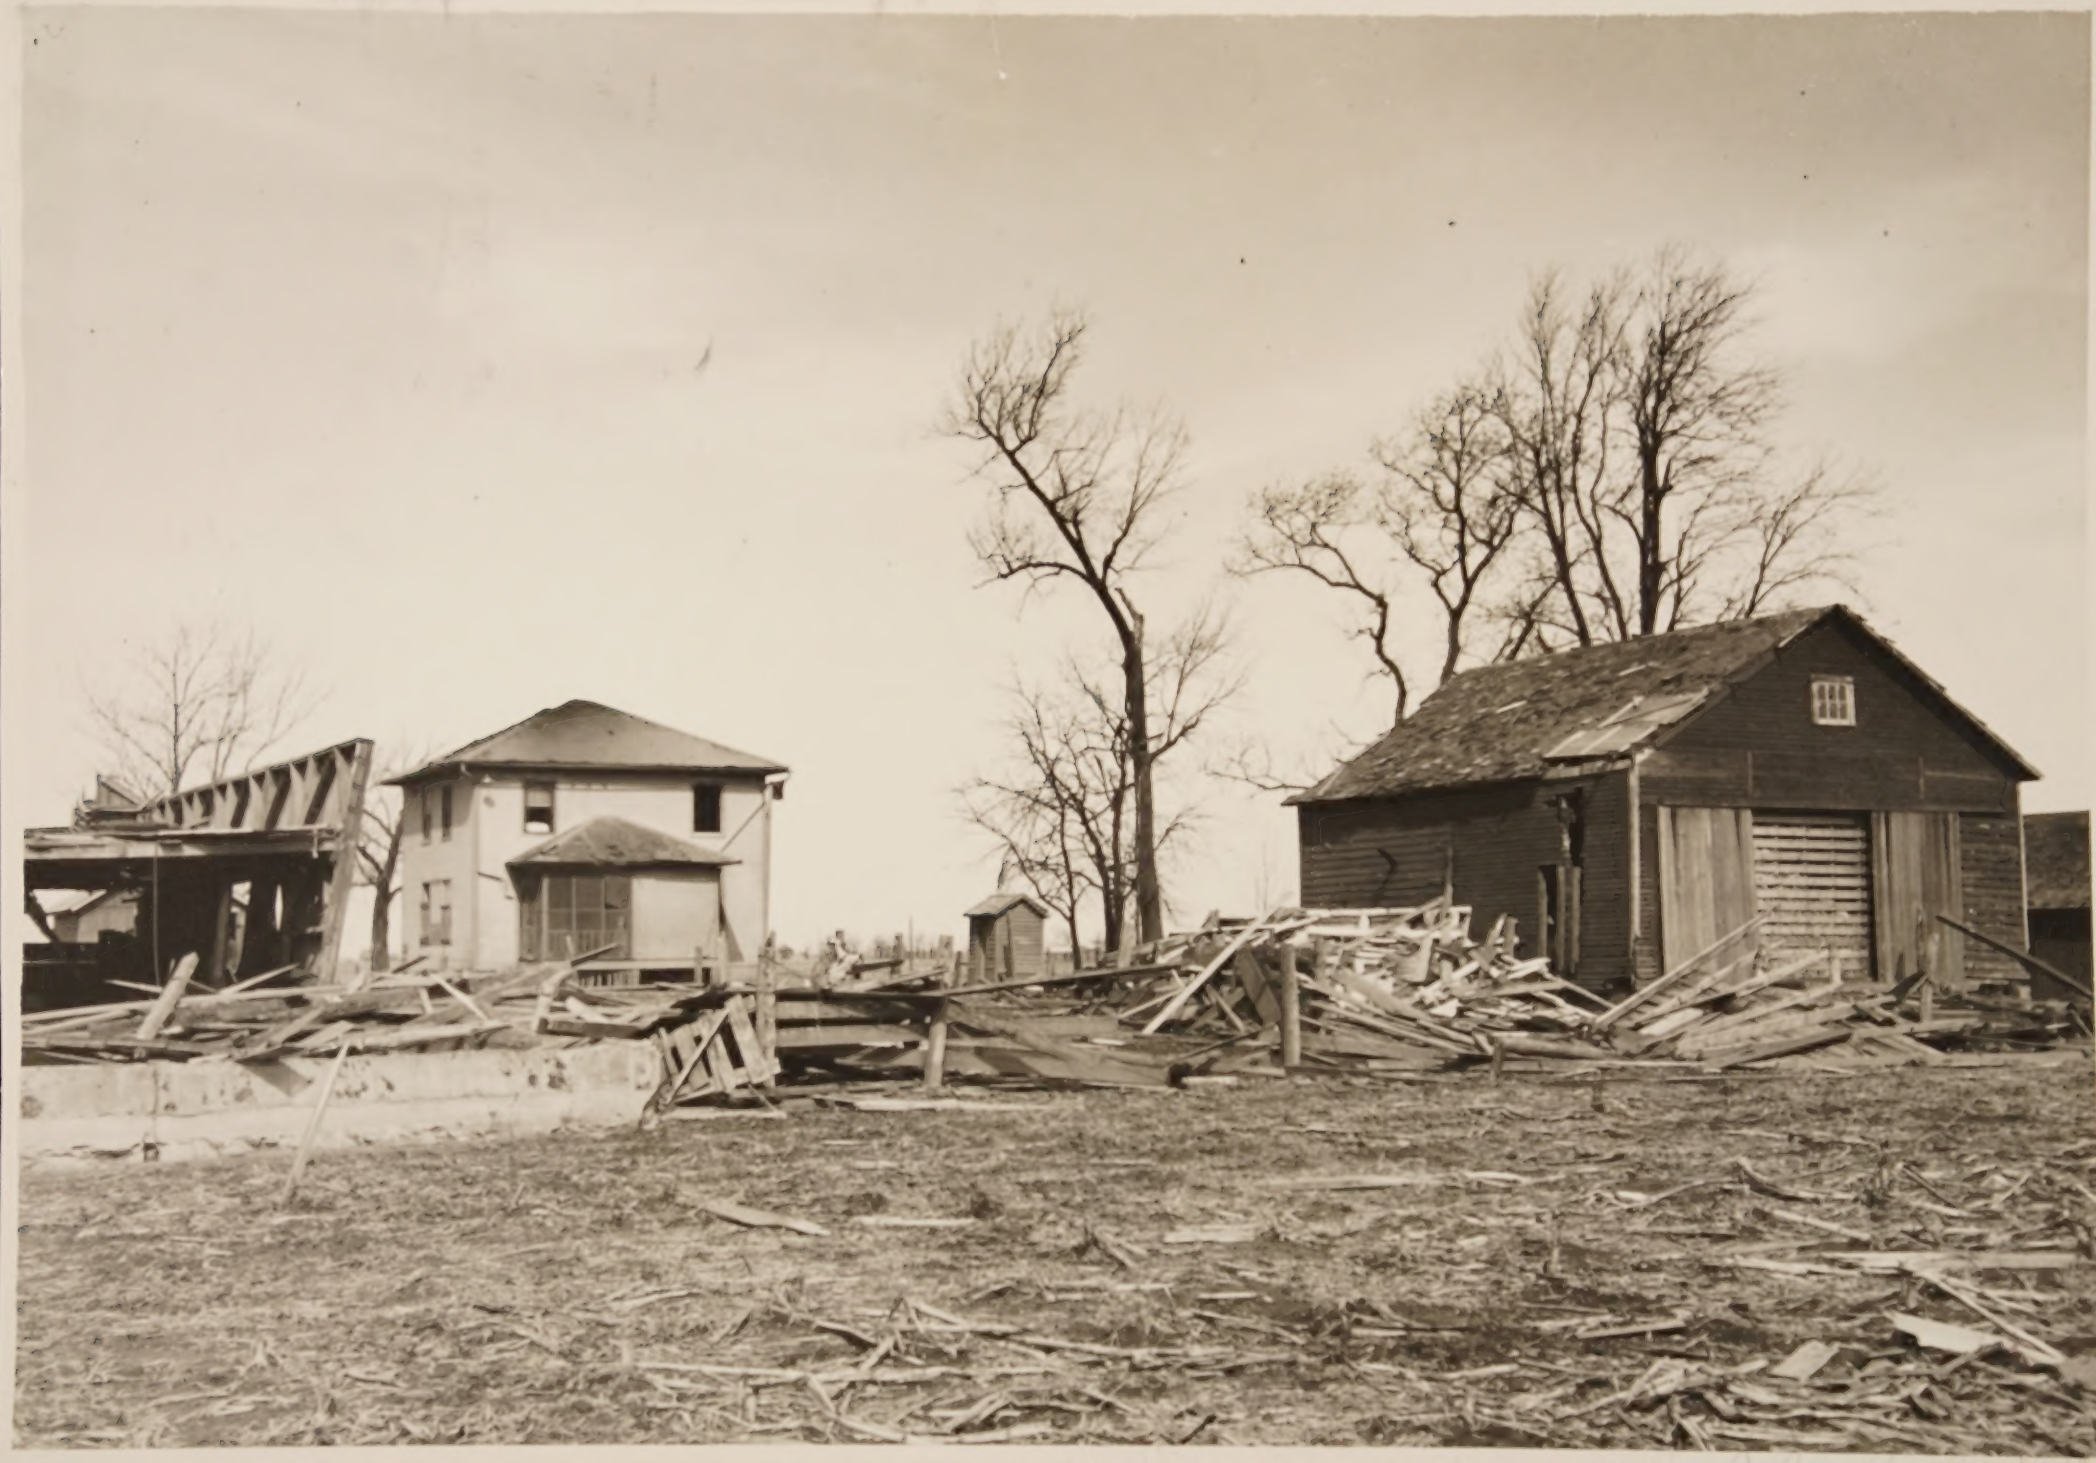
Subject Remains of poultry house - Center foreground

- Struck by tornado 5:00 p.m. April 29. Corner of  
barn shown in photo #1 can be seen at left. Corn-

crib on right had only the roof damaged.

Windows of house in background were all sucked  
out and the brick chimney (top center of house)  
torn off.
